Case Number: S2023000024 Rev A

Symptom/Vehicle Issue: Water Leak Rear Of Cab Rear Seat Or Headliner

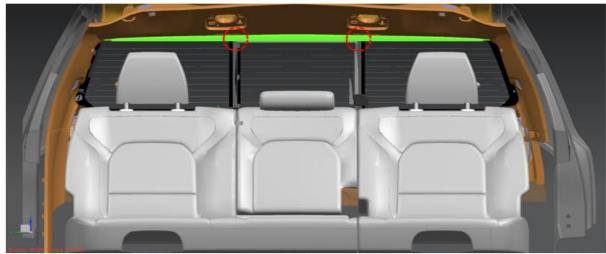
**Discussion:** Inspect backlite (rear window) upper plastic frame for cracks. If part shows visible marking near red circles in Figure 1, run fingernail across suspect area.

Figure 1 - Inside Truck Cab, Light Green Part is Upper Plastic Frame of Backlite, Red Circles are Potential Crack Locations

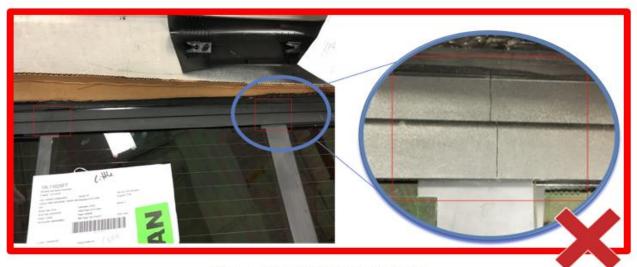
- If you feel and see physical cracks separation in the upper frame, probable cause is water leak due to cracked backlite upper frame and backlite should be replaced. See Figure 2.
- If you do NOT feel physical crack, yet still see visible line marking, this is a KNIT LINE due to injection molding process and is a GOOD part. See Figure 3.

Figure 2 - Cracks in Backlite Upper Frame

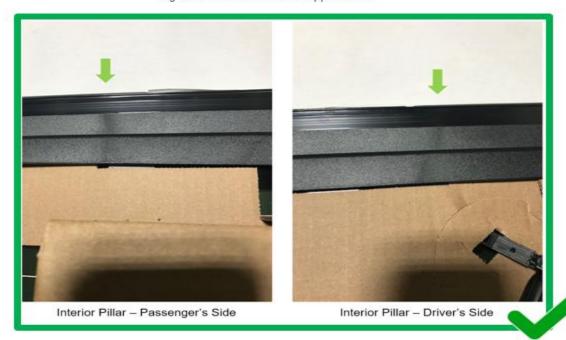
Figure 3 - Backlite Upper Frame KNIT LINES
